DELAMAR WEST HARTFORD

1 MEMORIAL ROAD, WEST HARTFORD, CT

COOLING TOWER

ASK-43b

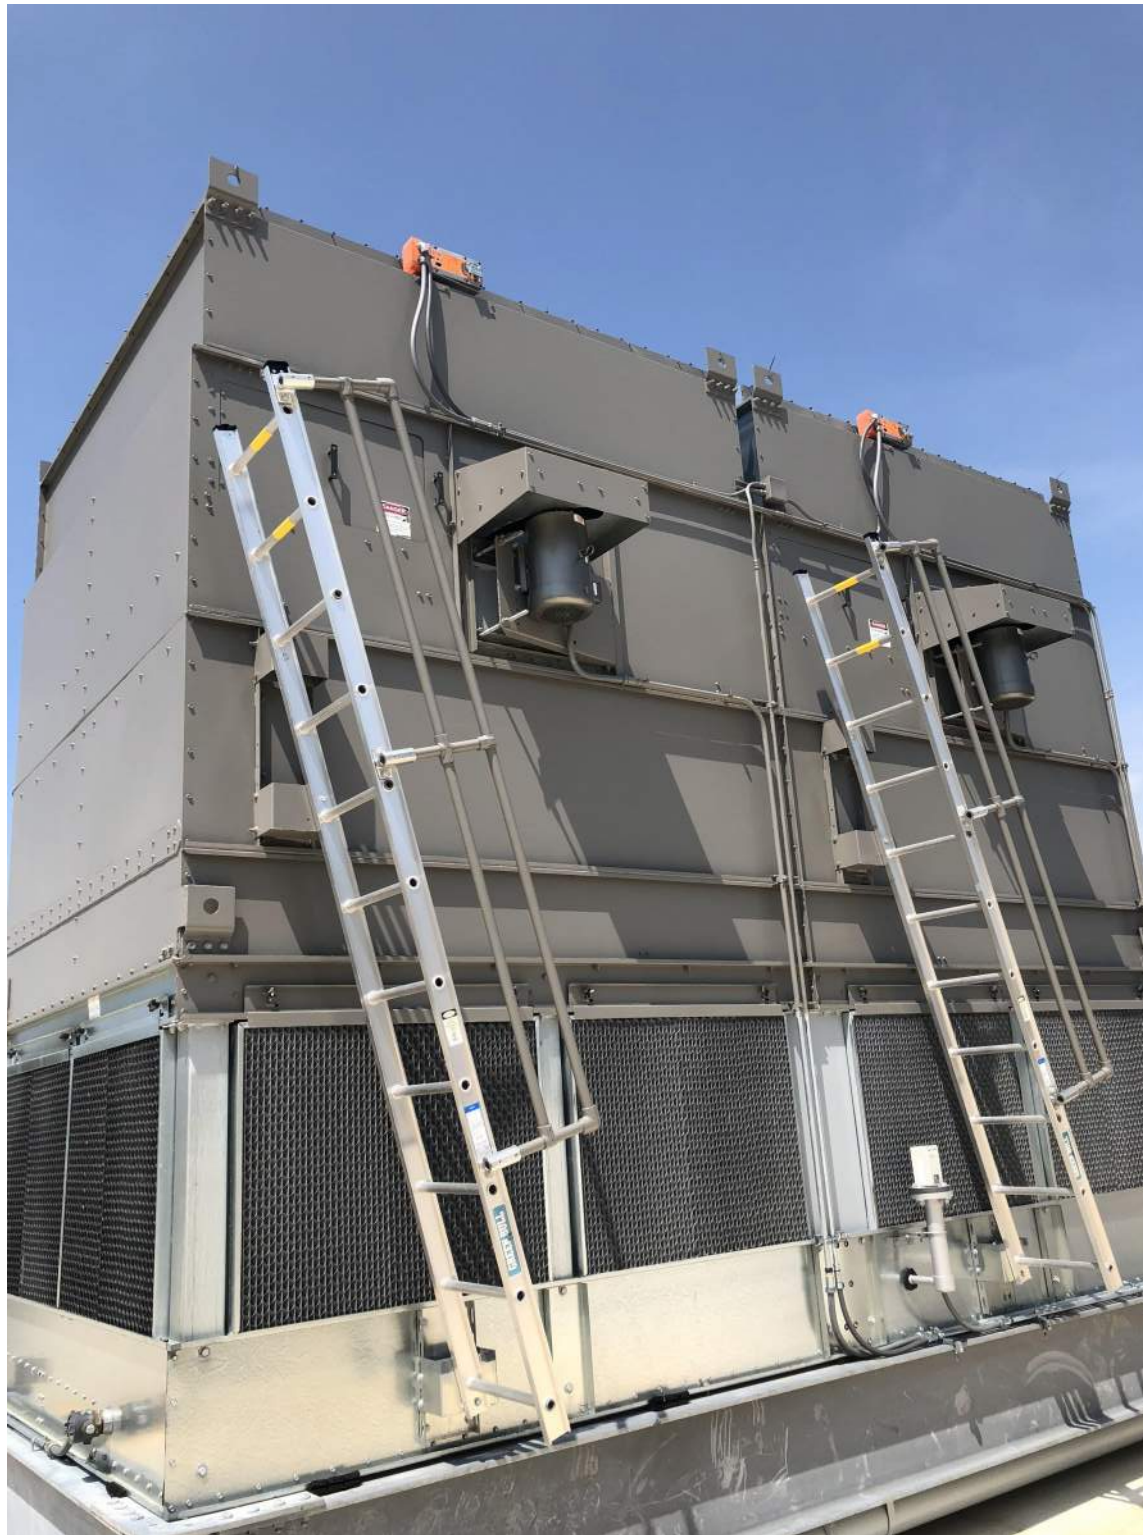
EXISTING CONDITIONS AT EAST FACE

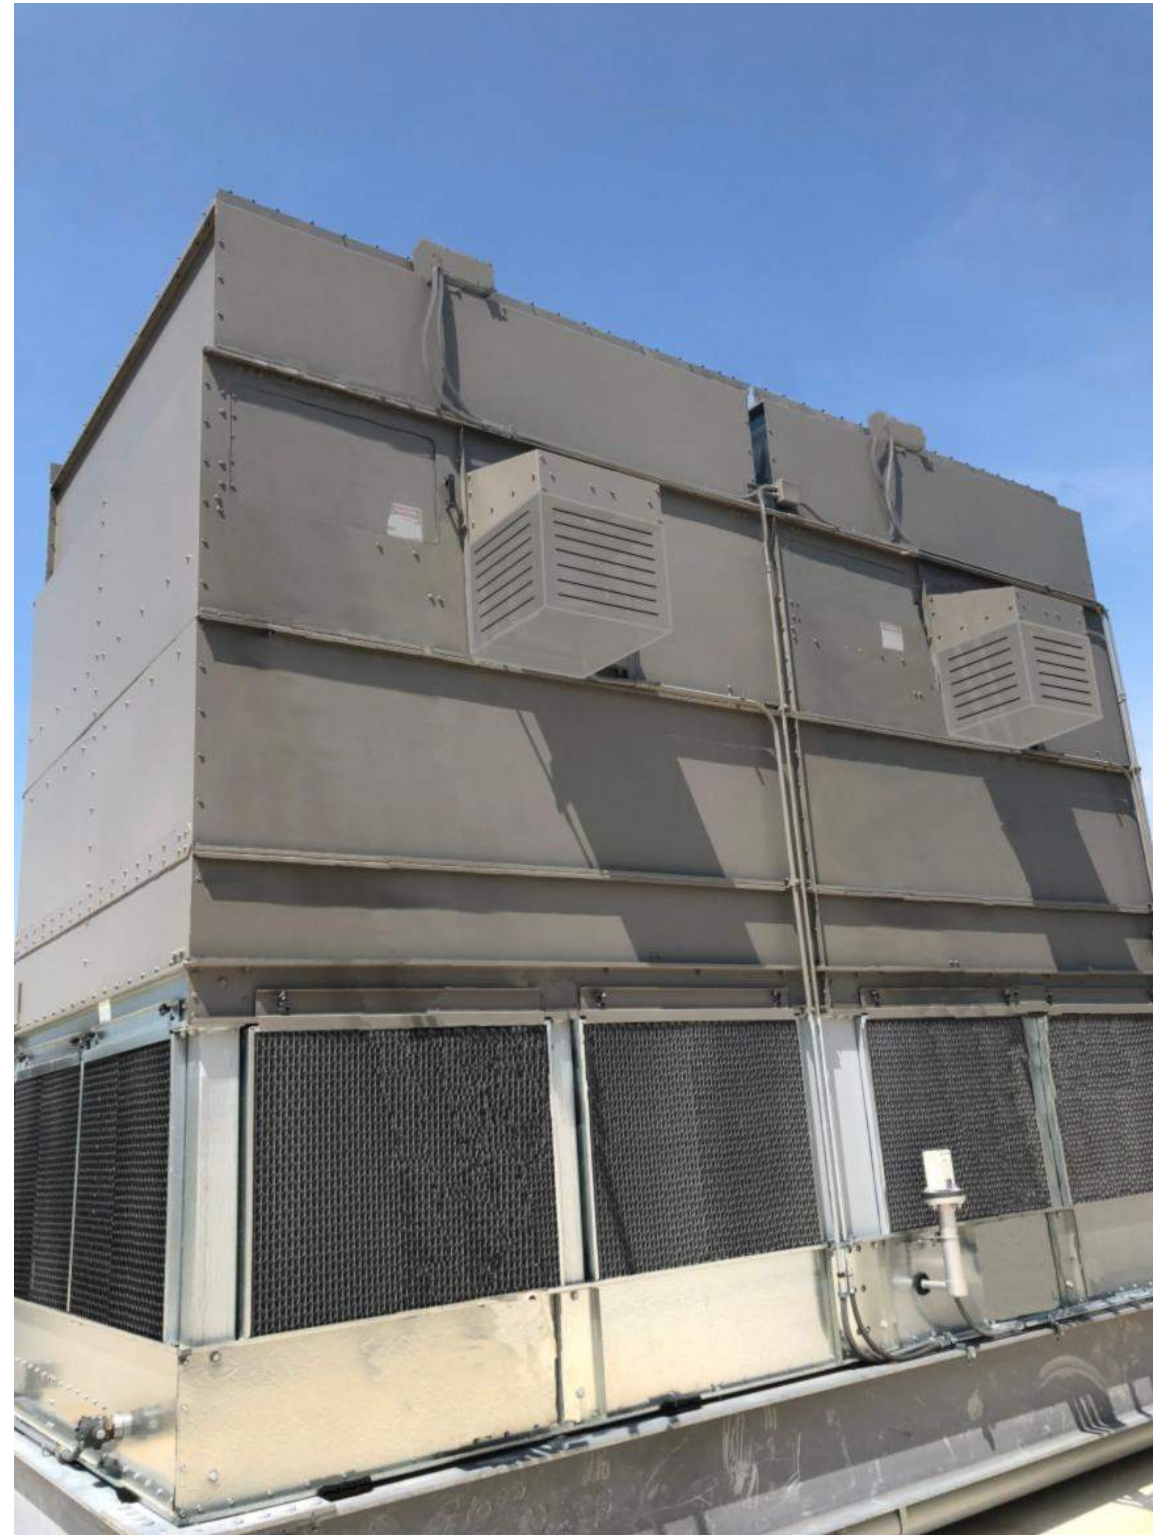
PROPOSED CONDITIONS AT EAST FACE

LADDERS AND LADDER ATTACHMENT POINTS REMOVED
 CRANE ATTACHMENT POINTS REMOVED
 PAINT ACCESSORIES PREVIOUSLY UNPAINTED
 ENCLOSE FAN MOTORS IN LOUVERED SHEETMETAL HOUSING
 ALL PAINTED TO MATCH METAL ROOF COLOR

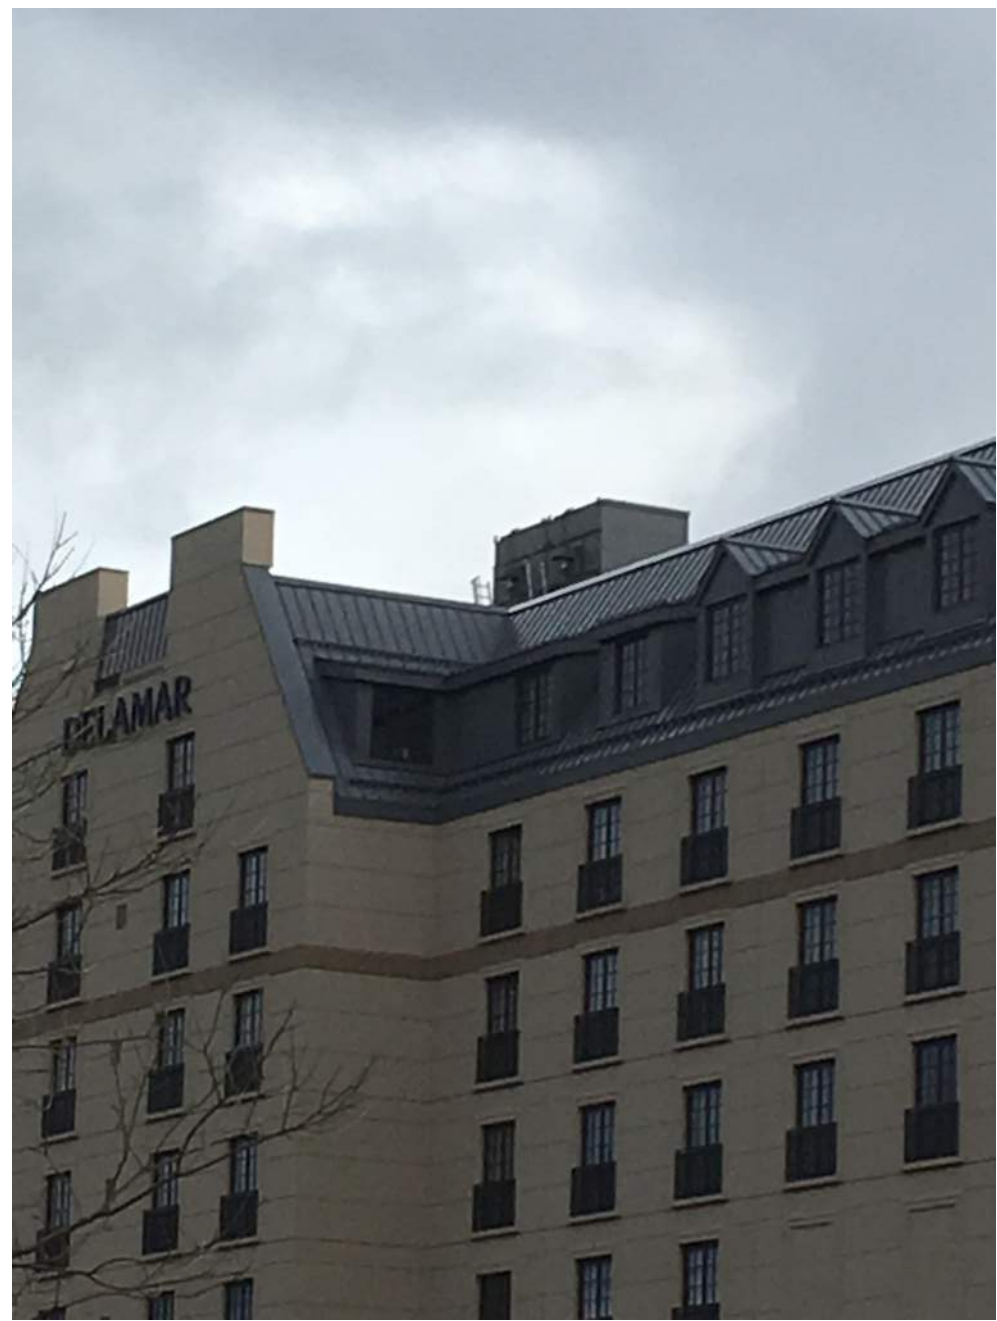
EXISTING CONDITIONS NORTHEAST VIEW

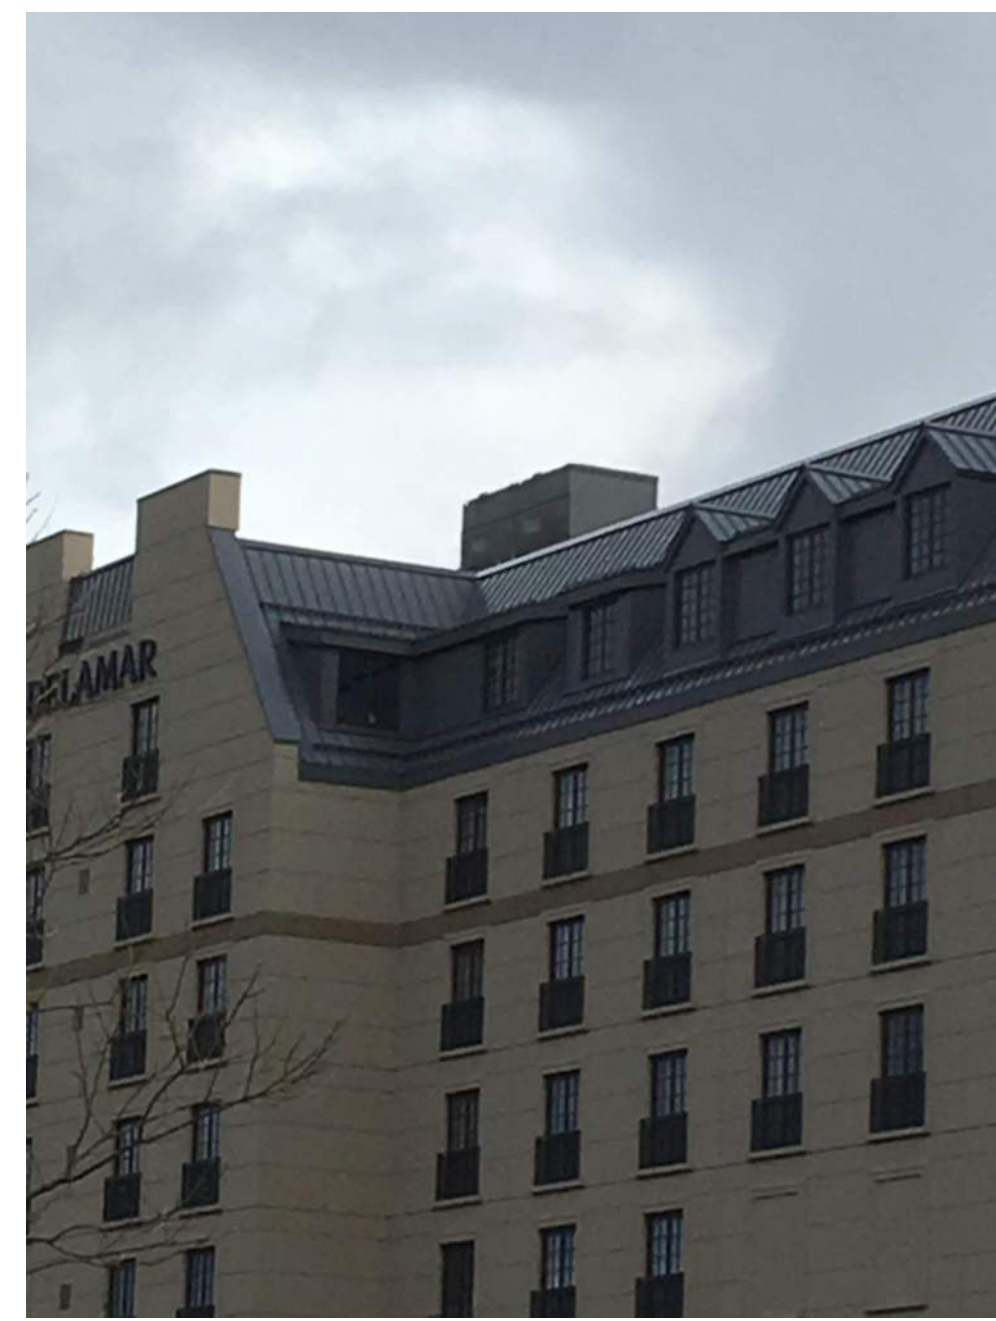
PROPOSED CONDITIONS NORTHEAST VIEW

- LADDERS AND LADDER ATTACHMENT POINTS REMOVED
- CRANE ATTACHMENT POINTS REMOVED
- PAINT ACCESSORIES PREVIOUSLY UNPAINTED
- ENCLOSE FAN MOTORS IN LOUVERED SHEETMETAL HOUSING
- ALL PAINTED TO MATCH METAL ROOF COLOR
